# Rig – Crack sealing

MetaLine® Series 700 – Sealing and corrosion protection in the offshore sector

Reference and Photos:  
Floatel Superior (2020)  
(built by Keppel, Singapore)

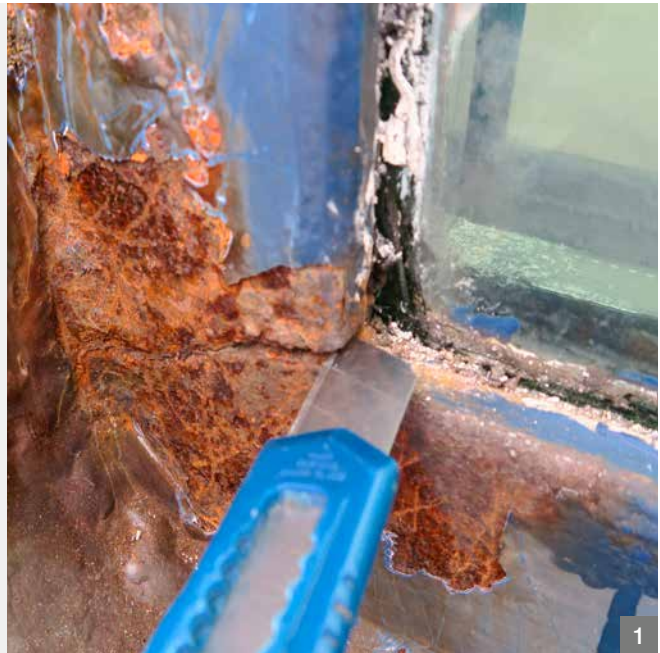
About 150 window-frames of this hotel platform were cracked causing saltwater to enter the inner steel structure.

After an initial test with MetaLine® 785 in 2017 the platform owner decided in 2020 for a complete elastomeric treatment involving more than 450 cartridges of MetaLine® 785.

In addition the damaged window rubber seals were overcoated. The most exposed horizontal bottom seal was casted on top with a 10 mm (0.39 in) coat to provide additional sealing safety (Pic 8).
