# Bellows

MetaLine® Series 700 – Repair technique for the sealing of textile expansion systems

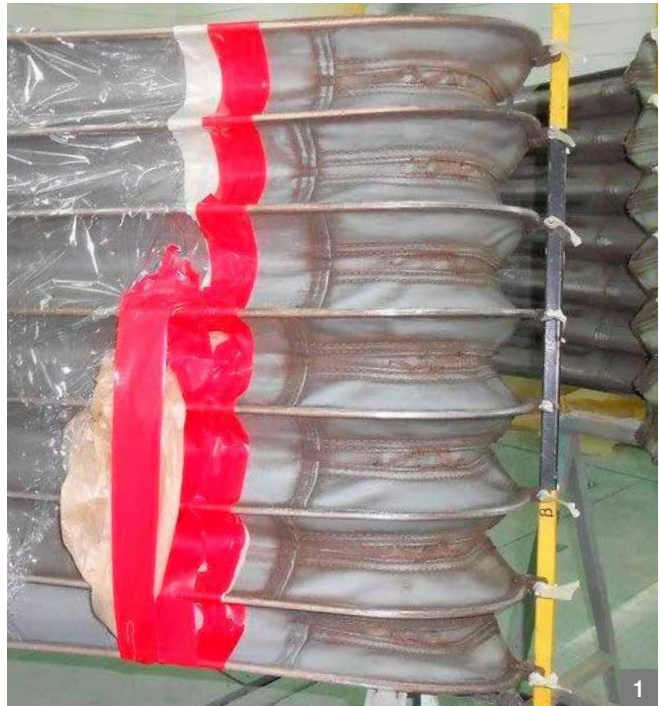
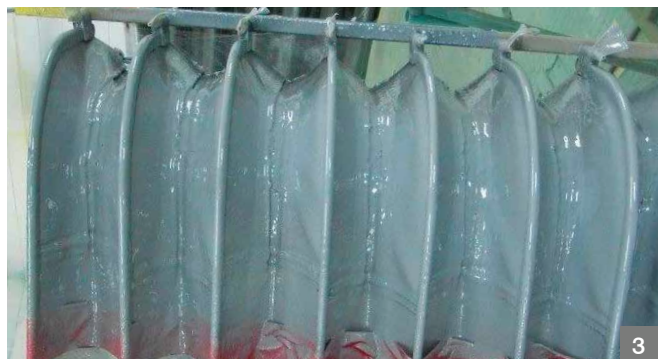
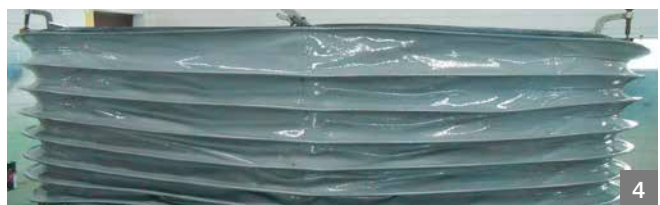
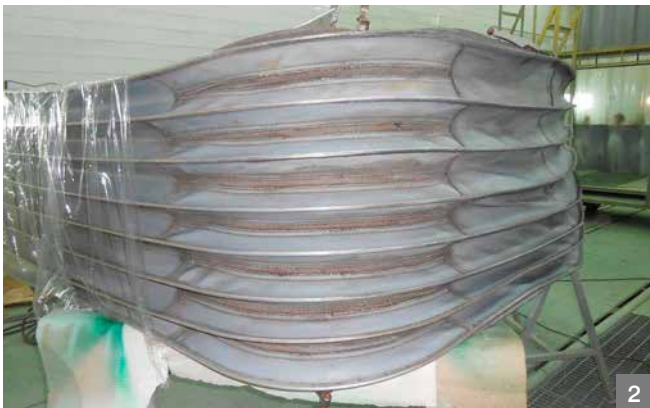
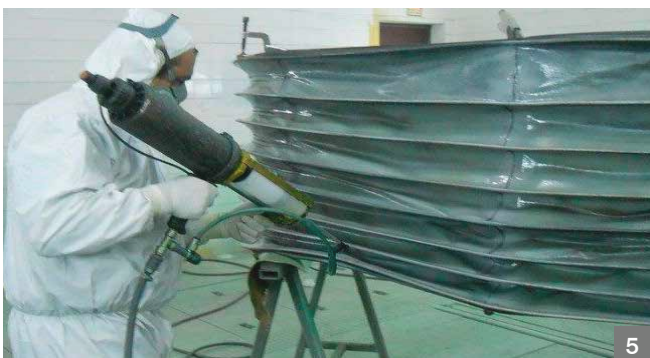
Reference and photos:  
Lisboa Public Transports (Portugal)

The highly elastic MetaLine® 760 can be applied to textile substrates and reliably seals against moisture and water under pressure. In addition the coating system acts as a thermal insulator (about 0,2 W/m.k).

- weather-resistant and absolutely waterproof (even in driving rain)
- available as electrically insulating or anti-static version
- can be applied on-site for smaller local repair purposes
